HOME CONDITION REPORT

1234 Great St Righthere, KS

Inspected By: Mr. Inspector
Inspect America, LLC
P. O. Box 186 Lansing, KS 66043
913-680-1757 Fax: 913-680-1758

Inspection Date: 08/08/2011

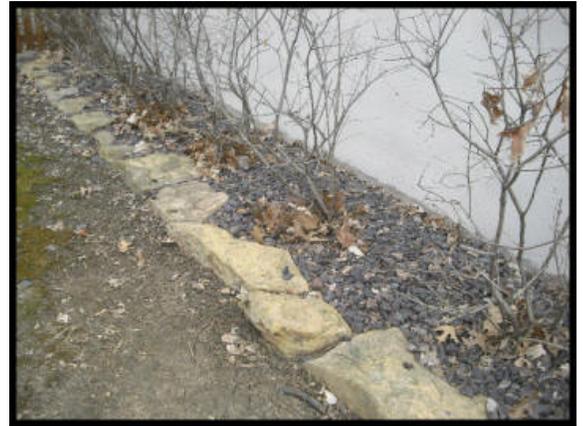
Attention Needed - The drainage around the foundation should slope away from the foundation at a rate of 1/2" per foot for 6' from the foundation. Portions of the ground around the perimeter do not meet this minimum standard. Most noted along the West side of the house.

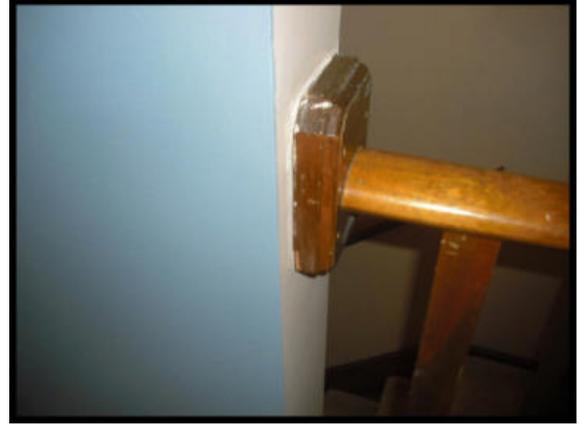
Attention Needed - Some portion of the staircase needs attention to perform satisfactorily. There is a handrail installed but it is loose or needs repair. Rail to wall connection is loose.

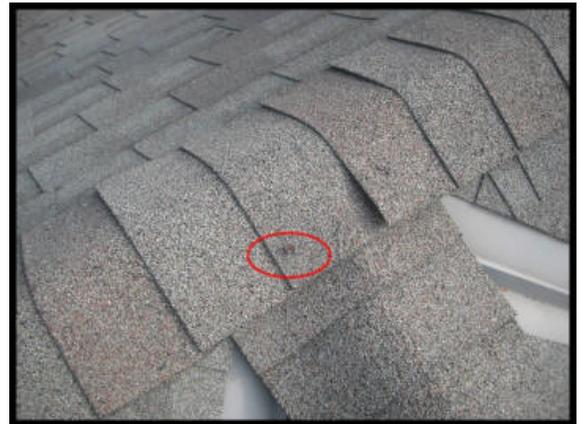
Ridges:

Attention Needed - Some portion of the ridge(s) needs attention. There is at least one nail head that needs to be sealed.. Noted at the center of the ridge. The ridge is showing some granular loss. It will need replacement before the remaining portion of the roof..

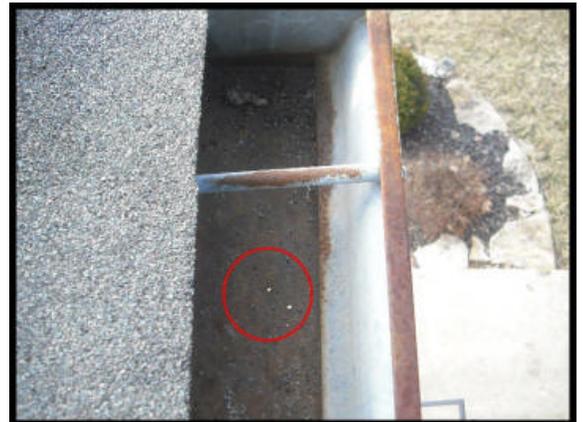
Action Necessary - The gutter system on the roof edge does not appear to be working, possibly due to open seams or parts missing. There are small holes in the gutter, near the South end above the front entry. The downspouts appear to be clear and functional. The splashblocks appear to be able to carry the run-off water far enough away from the foundation to be considered satisfactory. Installation of the downspout extensions help carry the water further away from the foundation.

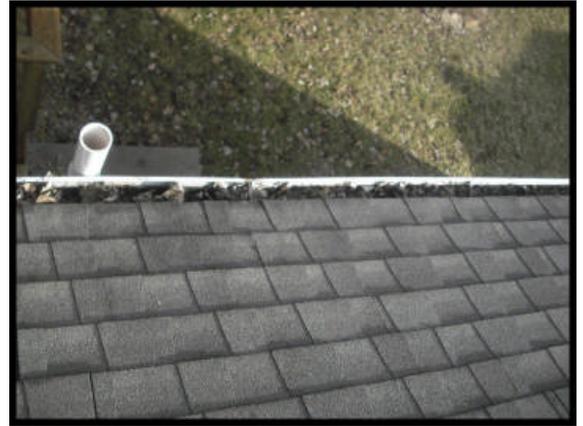
Attention Needed - The gutters need to be cleaned.

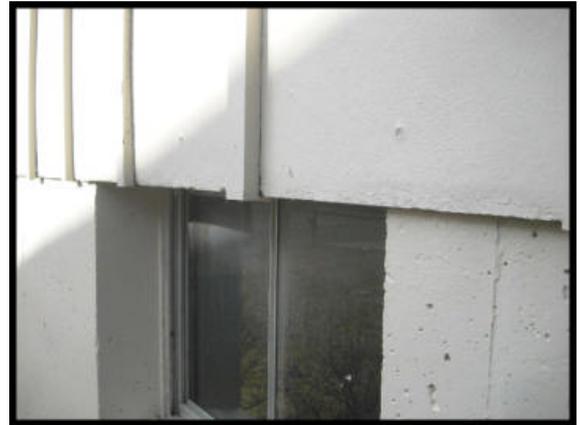
Attention Needed - The exterior siding material or finish is in a condition that requires minor repair to prevent further deterioration. Swelling and deterioration of the fiberboard siding appears to be a result of some combination of: lack of paint on the bottom edge of the siding material allowing moisture to wick into the siding, nail heads that may have been driven in too deeply exposing the fibers to moisture, or inappropriately placed nails or open nail holes exposing the fibers to moisture. Noted at the lower edge of the panels where paint is insufficient. The worst areas are the lower edge along the East side of the structure.

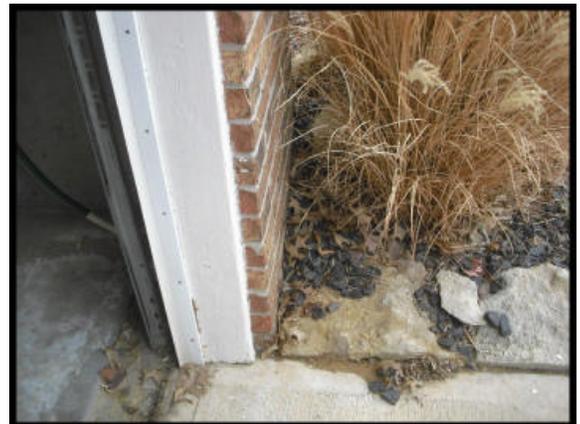
Brick Condition:

Attention Needed - The exterior siding material or finish is in a condition that requires minor repair to prevent further deterioration. At the East corner of the garage the brick is now below grade. The sheetrock on the interior of the garage shows evidence of moisture leakage through the brick. The soil needs to be pulled back along that wall. To prevent the brick from staying wet, and allowing water to wick into the wall.

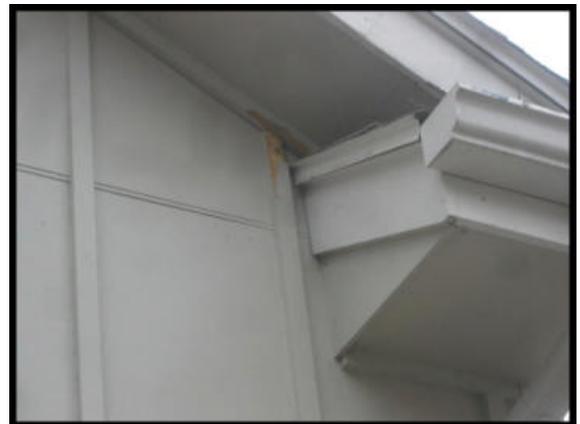
Trim Condition:

Action Necessary - Some portion of the trim currently is deteriorated to the point that it needs replacement. There is at least one vertical trim board on the East side of the structure that is rotted and needs to be replaced.

There is at least one trim board at the soffit to roof edge at the Southwest rake that has animal chewing evidence. These trim boards need replacement.

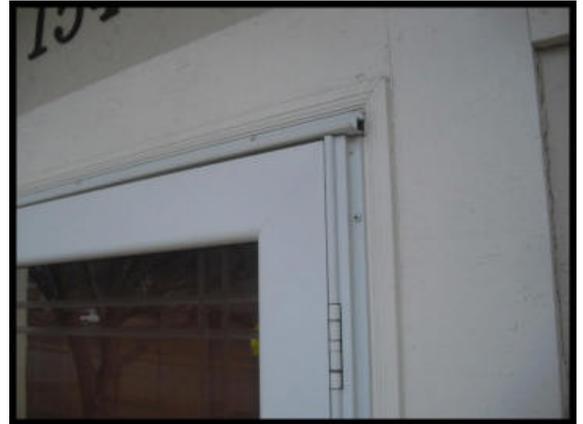
Action Necessary - At least one window has no visible flashing installed. Metal flashing prevents water from getting behind the siding. As a result of this condition, frequent care will be needed to maintain protection from water intrusion. |Over the front entry door.

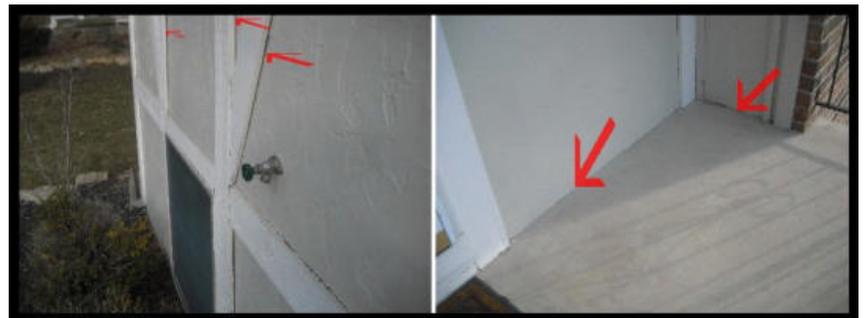
Action Necessary - Caulking around all wall penetrations and most siding joints is necessary. There are areas of the structure that either were never caulked or need immediate caulking. This will help prevent further deterioration. Caulk should be applied to areas where brick and wood siding meet, trim around window frames or doors, and piping and service penetrations. Also, any cracks that allow moisture or wind entry should be caulked to prevent deterioration. **Recommend -** Recommended sealants include various brands of materials that are a combination of silicone and latex. The combination of materials allows for the sealants to be flexible and paintable. Use caution when using pure silicone since silicone is not a paintable material.

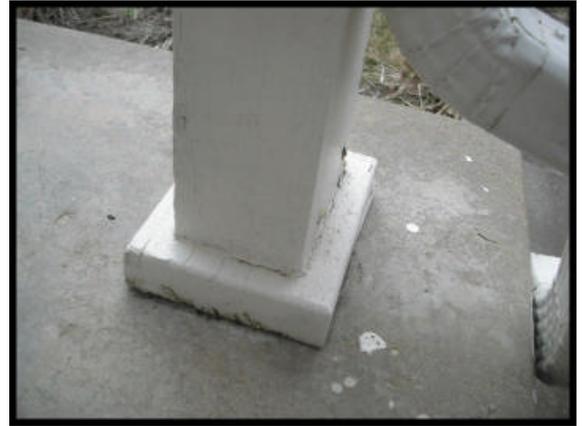
Attention Needed - The columns on the front porch are not sealed to the slab. Sealant needed to prevent further moisture deterioration.

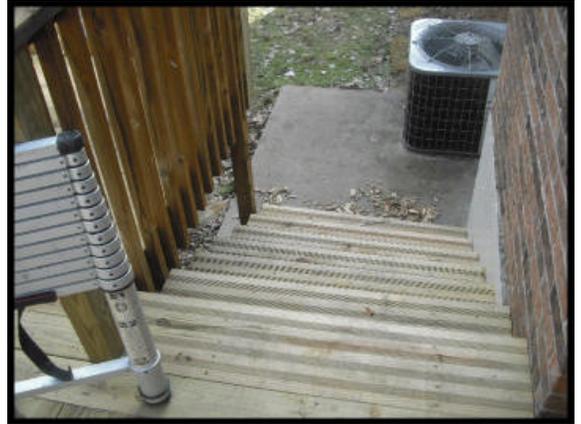
There is no handrail. Any staircase of over 30 inch in height must have a handrail for safety reasons. This staircase is over 30 inches high and needs a handrail installed.

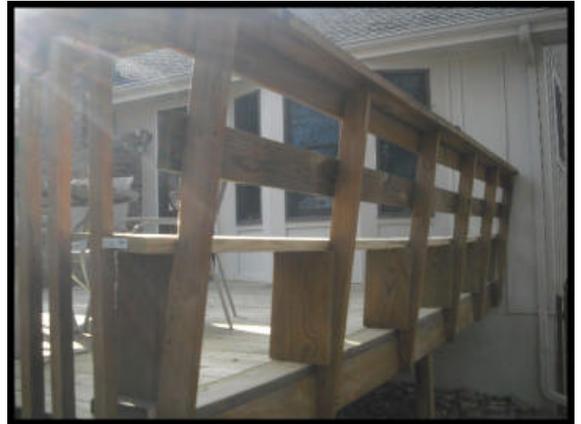
Action Necessary - The railings are in a condition that require repair or replacement. Chair Rail seating is installed. This horizontal arrangement is not preferred since a child can slide off the deck under the seating area. Recommend installation of a guard, with no more than 4" spacing, on the outside of the seating area to prevent an unsafe condition.

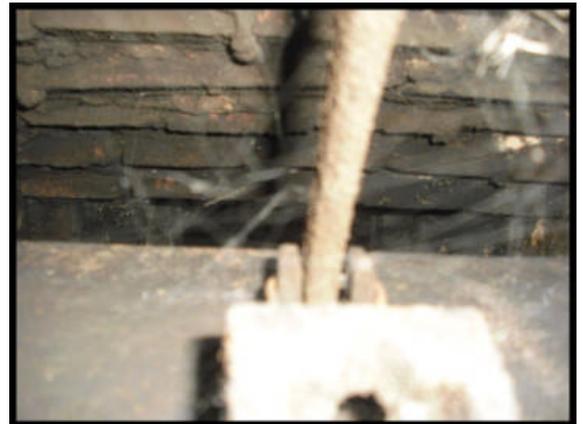
Attention Needed - The smoke chamber walls are sloped towards the flue; however, the chamber walls are not smooth and produce turbulence in the chamber which may create drafting problems. Parge coating needed.

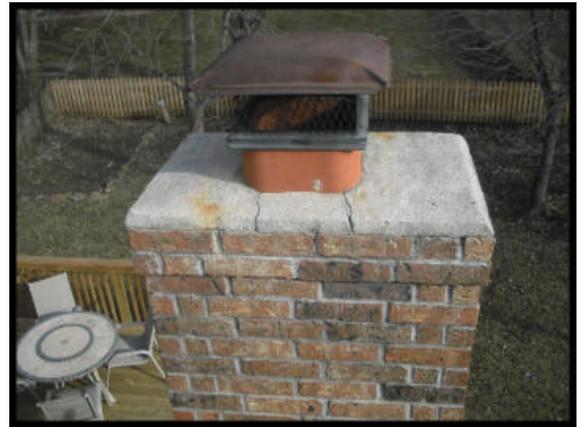
Attention Needed - The chimney cap is made of mortar. Its function is to keep water from entering the masonry stack, causing deterioration. This cap needs some repair so that it can function as intended. There are cracks in the crown that need repair.

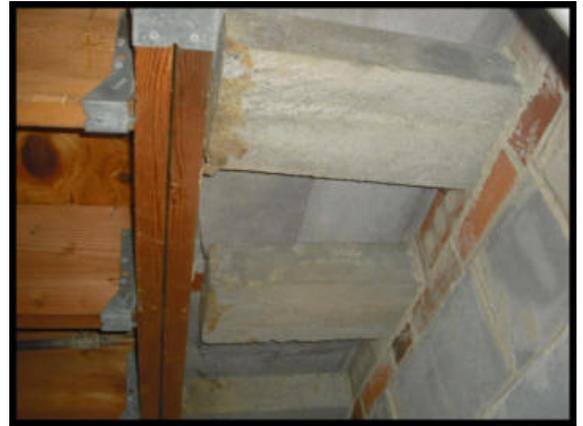
Attention Needed - There are missing nails in the hangers under the hearth extension.

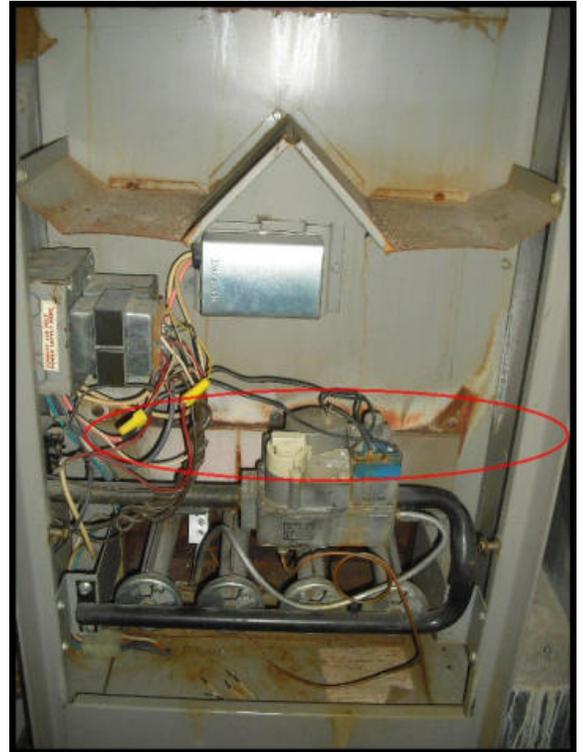
The heat exchanger was tested by a visual inspection with the aid of a flashlight and mirrors. No cracks or voids were noted. **Attention Needed** - The furnace heat exchanger needs to be cleaned. There is rust noted in the heat exchanger floor or in the flame spreader. **Action Necessary** - There is evidence of flame roll out. Services of a licensed HVAC Technician.

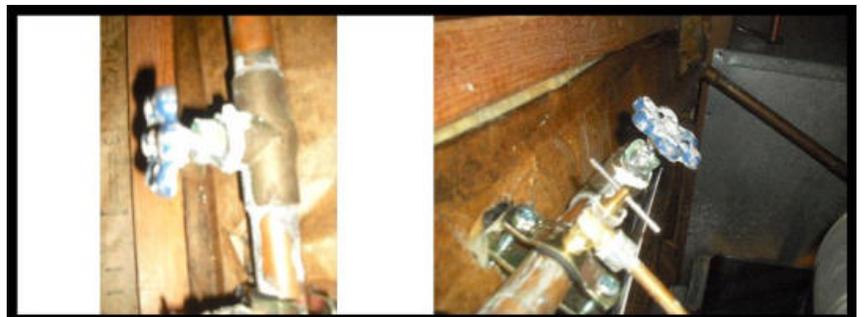
Water Piping Condition:

Action Necessary - The current piping condition warrants immediate repair. The cutoff valve is leaking and has been for some time there is rust on the exterior shell of the water tank.

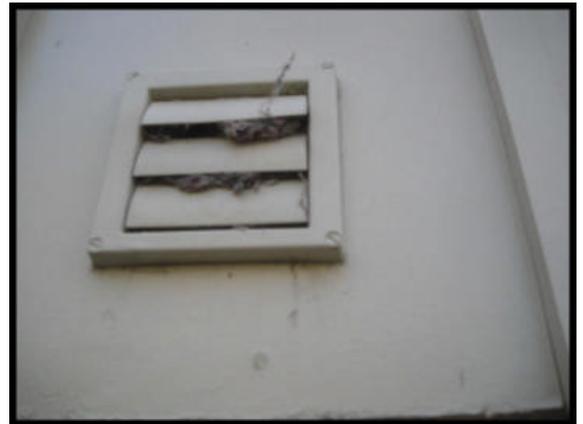
Dryer Ventilation:

Attention Needed - The dryer ventilation as installed appears to need maintenance or repair. A vent clogged with lint can create a fire hazard.

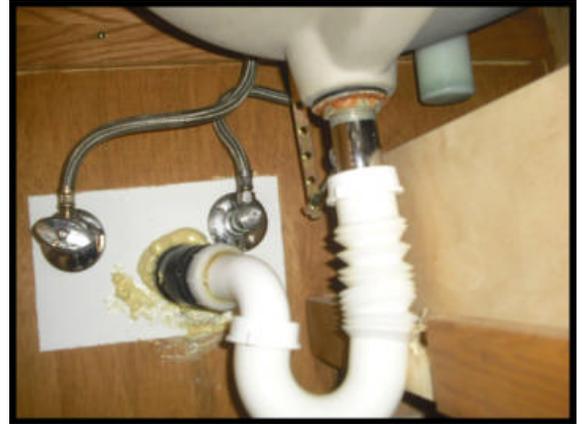
Action Necessary - The basin or drainage fixture is damaged or deteriorated to the point that action is necessary. There is an accordian pipe installed. Services of a licensed plumber is needed,

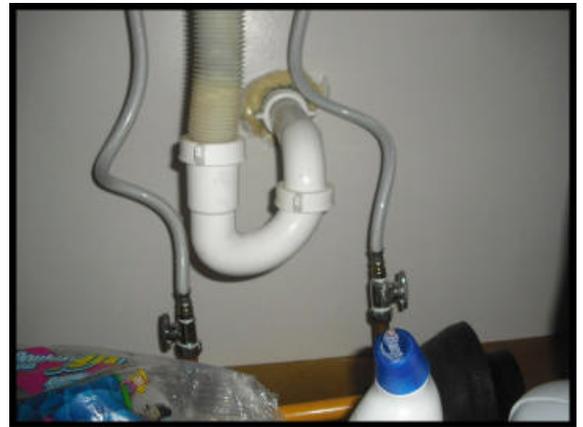
Action Necessary - The basin or drainage fixture is damaged or deteriorated to the point that action is necessary. There is an accordian pipe installed. Services of a licensed plumber is needed,

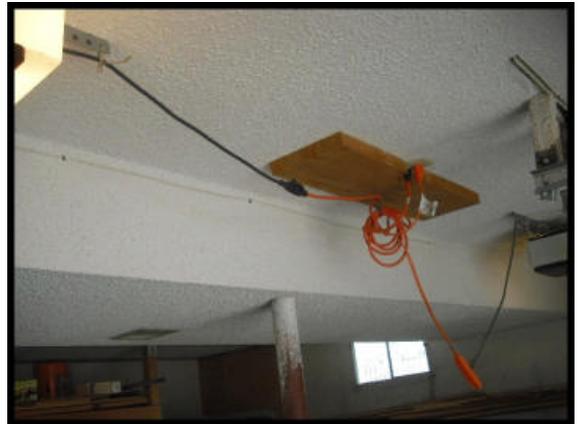
The overhead door opener appears to function appropriately. Action Necessary - It was noted that an extension cord is being used for power for the garage door openers. This condition is not allowed. The door opener must be connected directly to an outlet, not an extension cord, according to the manufacturer's installation instructions. Two additional outlets are required.

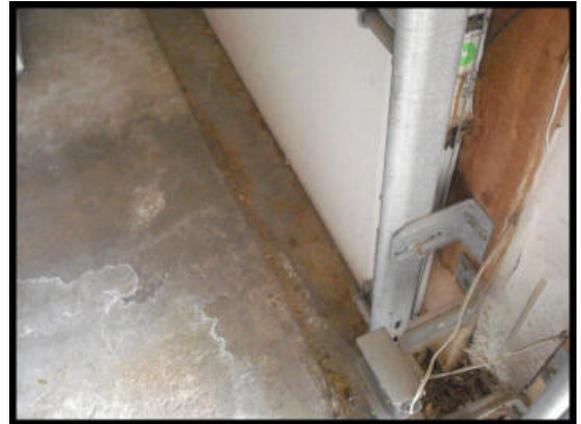
The garage door's automatic reverse mechanism was not tested using the resistance method. The industry standard requires the use of a 2" x 4" board laid on the floor, allowing the door to come down and hit it. When functional, the door will automatically reverse. This method has shown to break the top panel of metal doors and, on occasion, breaking the motor loose from the ceiling. Since we are not allowed to perform destructive testing, the only testing we will perform is a hand resistance test with the door moving downward. We strongly recommend that you perform the industry standard test shortly after closing on the property. There is an electronic beam safety reverse system installed. It does not function as intended. Right Door.

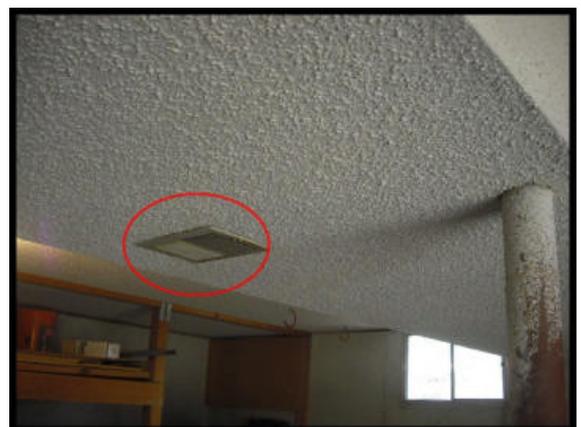
Good - Yes - The garage is heated. This is a good feature. Action Necessary - No fire rated dampers are installed in the supply duct. Even if it was not required at the time of installation of the ducts, fire rated dampers are a safety feature that should be considered for prevention of smoke or fire from entering the heating system and delivering the heat or smoke to other living areas of the house.

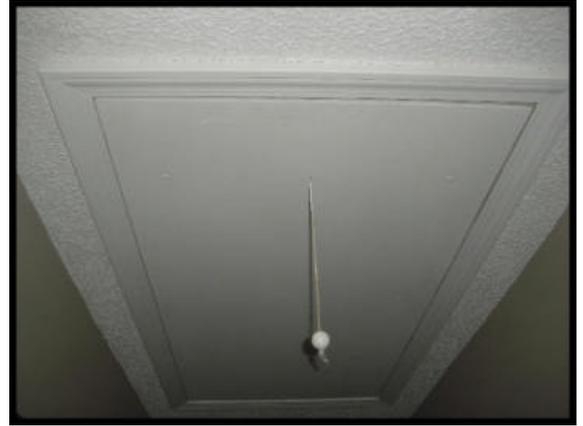
There is an abandoned hatch in the South center bedroom closet. It is not sealed closed.

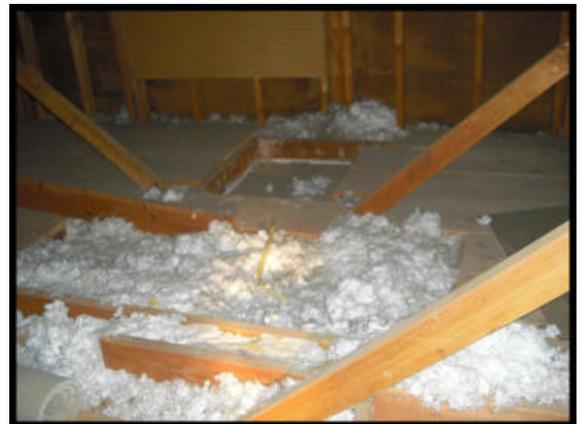
Action Necessary - The attic insulation appears to be insufficient to properly insulate the living spaces below. There is an average of at least 10" of insulation installed. Recommend - In the Midwest it is recommended to have an insulating value in the attic of R-30. For example, R-30 requires 10" of fiberglass insulation. If adding batt type insulation, be sure to add insulation that does not have a vapor barrier (paper lining) attached. The vapor barrier could trap moisture in the insulation.
