HOME CONDITION REPORT

1234 Great St Righthere, KS

Inspected By: Mr. Inspector
Inspect America, LLC
P. O. Box 186 Lansing, KS 66043
913-680-1757 Fax: 913-680-1758

Inspection Date: 08/08/2011

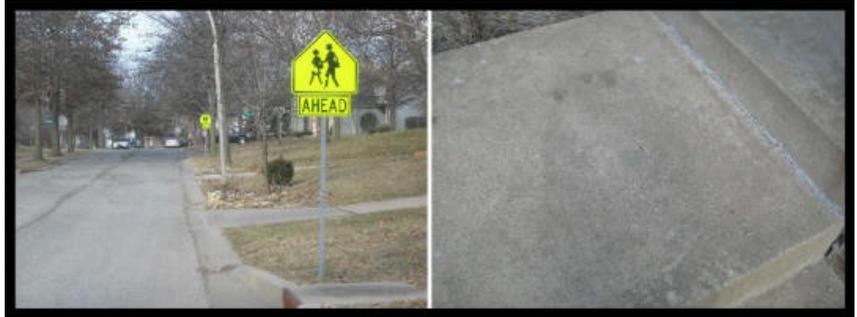
Walkway Condition:

Satisfactory - The walkway surface material is in satisfactory condition with only normal deterioration noted. There is some slight settling noted.. There is evidence of prior mud jacking. It does not appear that movement is ongoing.

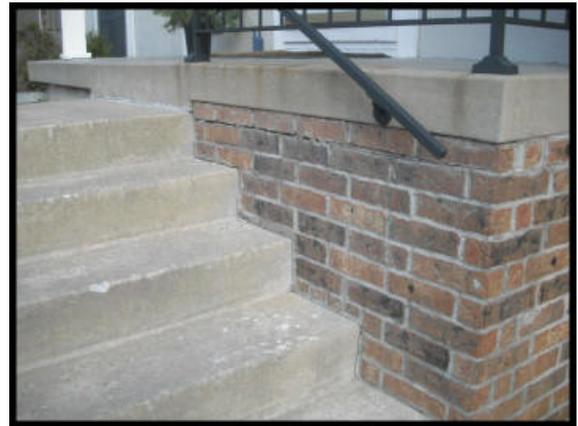
Comments:

Attention Needed - The brick facade under the front porch has settled leaving a gap in one of the mortar seams. This joint needs to be cleaned out and mortared.

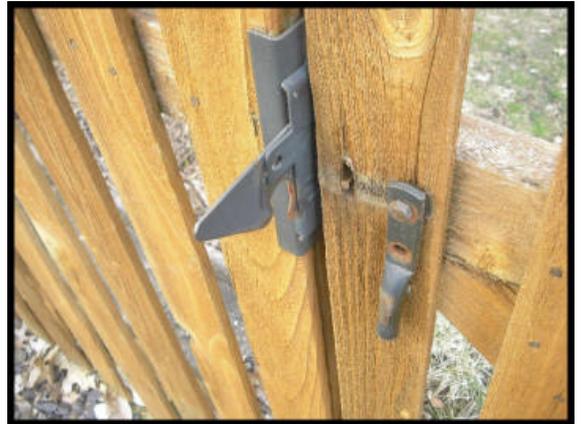
Gates and Latches:

Action Necessary - There is some portion of the latch's hardware that is nonfunctional.

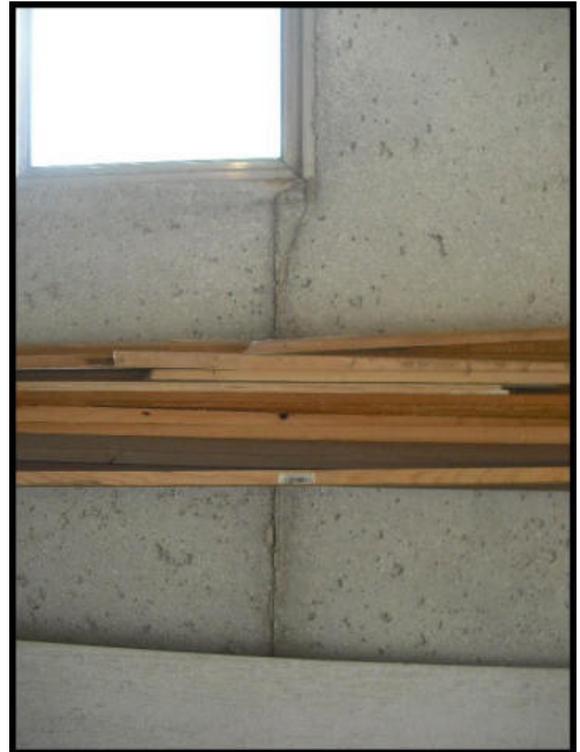
Shrinkage cracks are hairline cracks that are caused by the evaporation of water in the mix. This is a normal condition. Seventy-five percent of all shrinkage cracks appear in the first year. Under the left side of the garage window. There is no evidence of recent movement. The crack has foundation paint inside the crack indicating that the crack is an old one.

Pictured is the interior view of the crack.

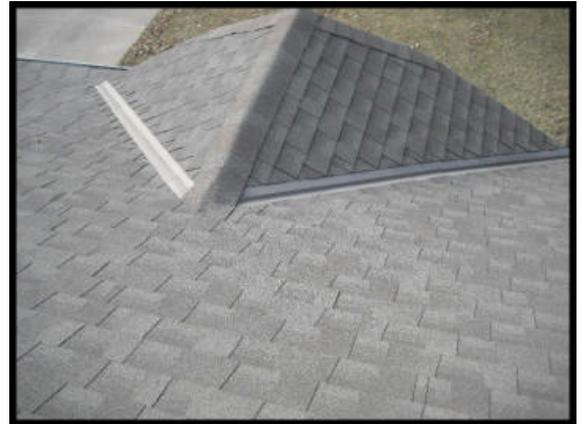
Satisfactory - The valleys appear to be in satisfactory condition. The valleys on the roof are open with metal valleys.

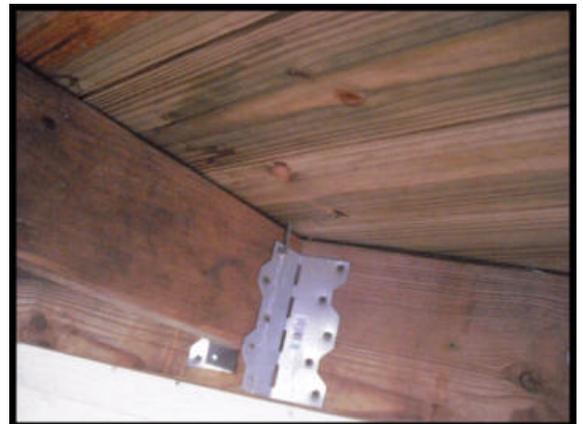
Framing of Deck:

Attention Needed - There are missing nails in the hangers under the hearth extension.

Attention Needed - There is some area of the framing that is in need of attention. There are joist hanger installed, however the nailing of the hangers does not appear to be correction. Some additional nails or fasteners are needed. The joist hangers manufacturer requires a specific nail to be used during installation. Screws were used and they may not be rated with the same shear strength as the manufacturer requires.

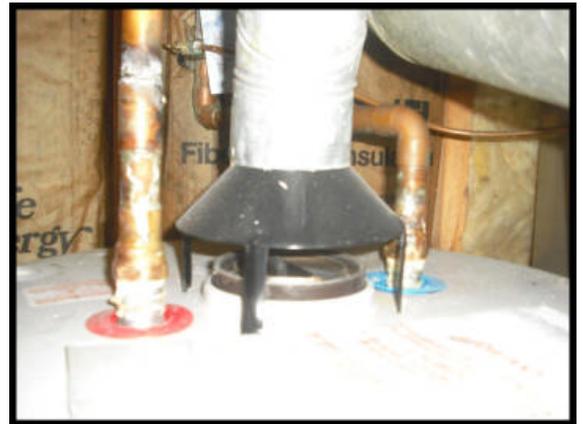
Flue/Exhaust Pipe Condition:

Satisfactory - The exhaust flue appears to be correctly installed. The exhaust flue pipe is metal.

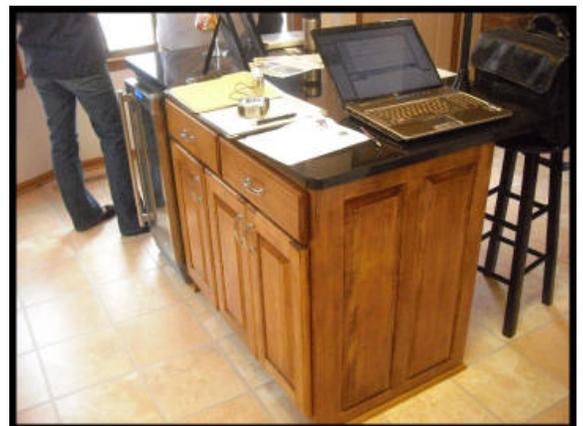
Good - The cabinets in this kitchen are of a better quality than expected. There is an island cabinet installed in the kitchen. The island appears to be adequately secured to the floor.

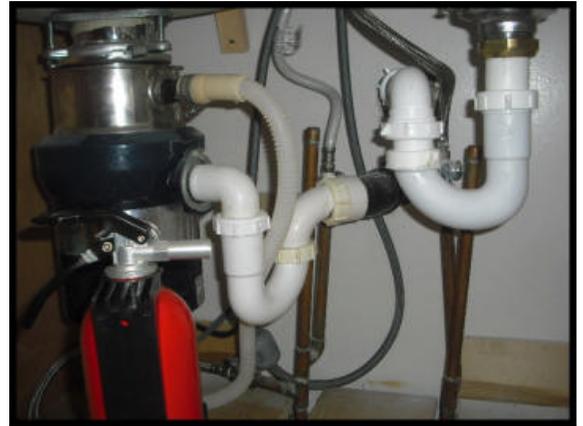
Satisfactory - Faucets and supply lines appear satisfactory with no leaks noted. There are shutoffs installed for both the hot and cold water pipes under the basin. The dish sprayer attachment is functional.

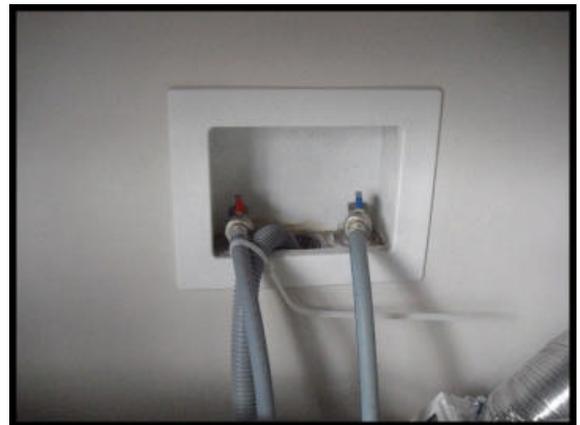
There is a connection box installed in the wall with both hot and cold water and a drain pipe. The drain pipe was not flood tested.

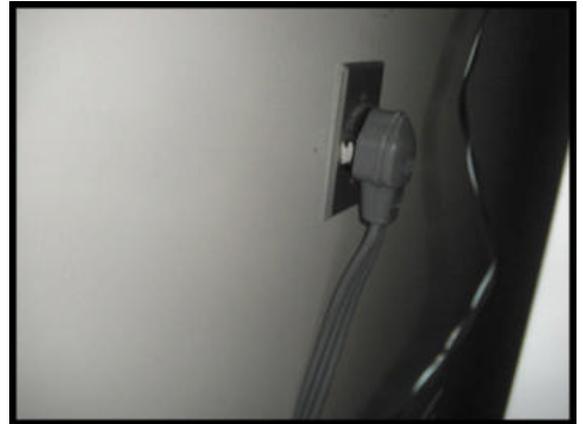
Yes - There is a 120/240-volt outlet provided for an electric dryer. If you intend to use a gas clothes dryer, you will need to have a gas line installed.

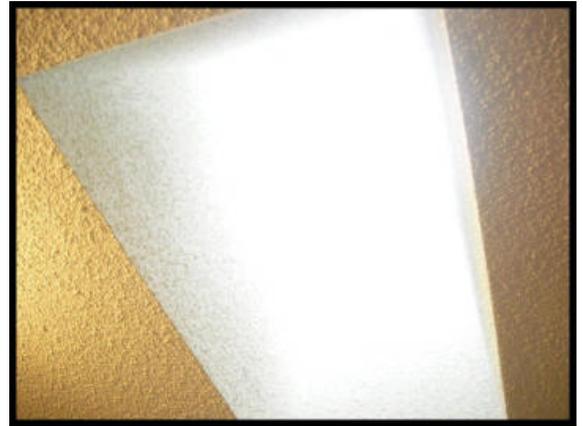
None - There are no windows in this bathroom. There is a fixed skylight installed.

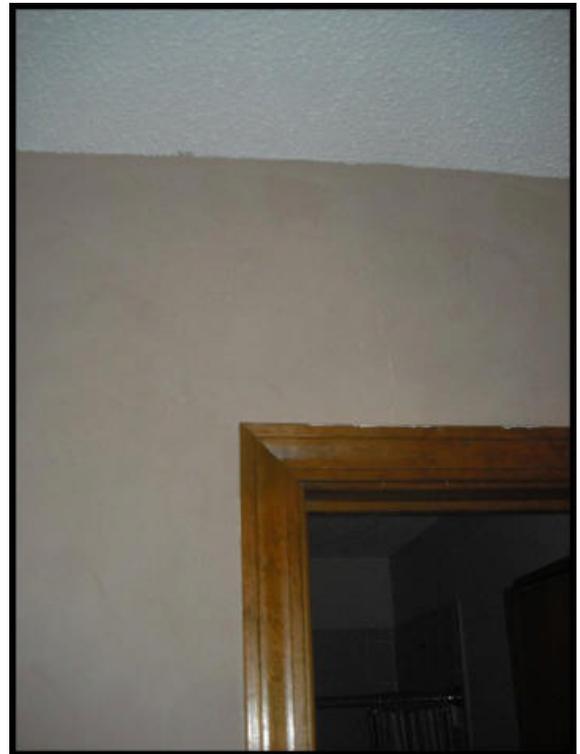
Satisfactory - The walls in the bedroom appear to be satisfactory. There is some minor cracking in the sheetrock. Most likely this is due to slight settlement or shrinkage.

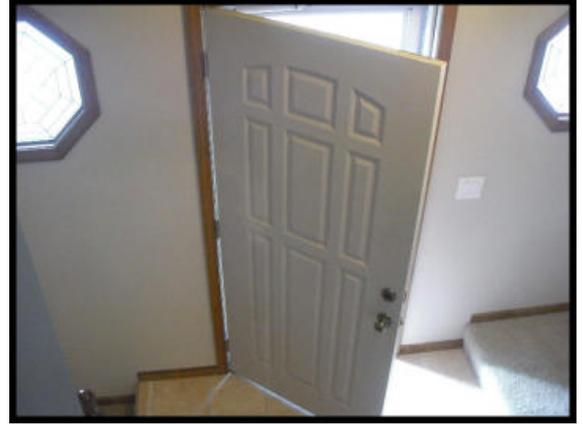
Satisfactory - The main entry door to the structure is in functional condition. There is a deadbolt installed on the main entry door, and it is operational. This is a recommended safety feature. **The guest at the front door is not readily visible. Installation of a viewing lens in the door would be a beneficial safety feature.**

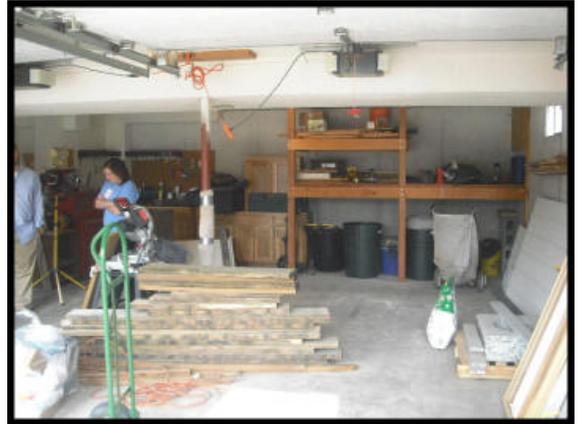
The garage is termed a tuck under, meaning that it is in the lower level with a living level above it.

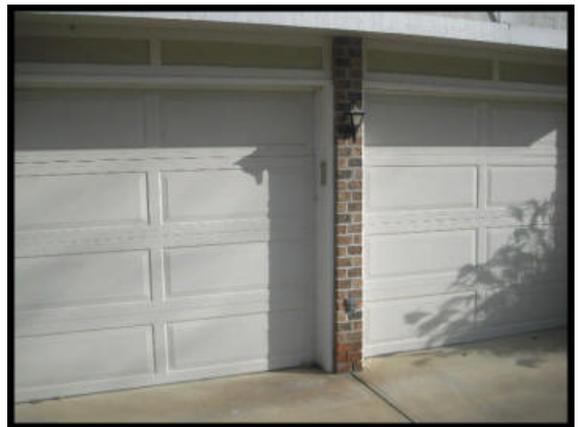
Two-car garage.

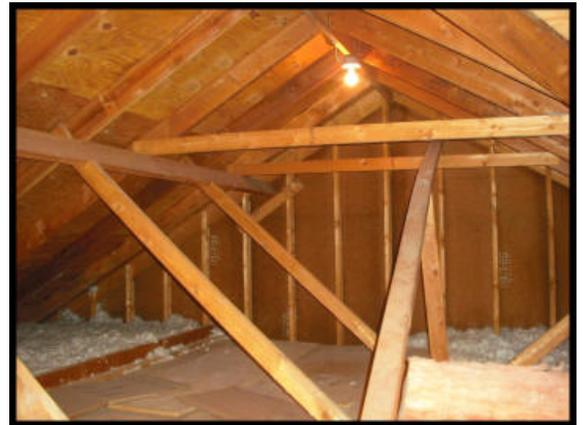
A rafter system is installed to support the roof decking. The rafter or truss system appears to be in satisfactory condition. The rafter spacing is 24" on center.

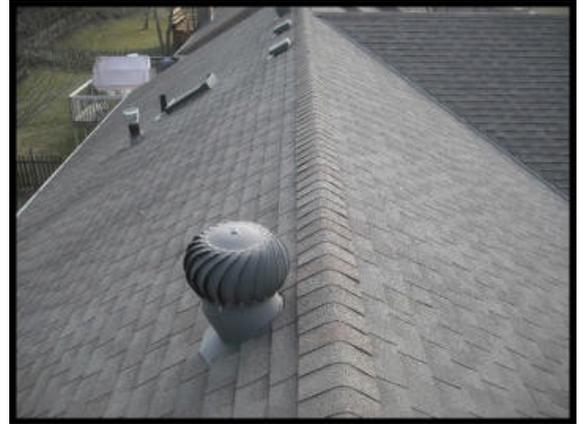
Satisfactory - There appears to be adequate ventilation installed. Vents are located both in the ridge area and low in the eaves area. There is at least one rooftop turbine installed. There are ridge vents installed.

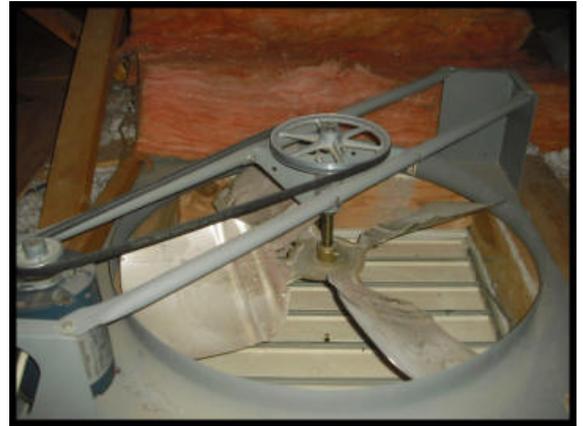
Yes - There is a whole house ventilation system installed. Functioning properly, this will assist at minimizing the air-conditioning costs during the cooling season on cool evenings with low humidity.
